# US 50 Blue Mesa Bridges ER Project

# Bridge K-07-B (Middle Bridge) 1st Determined Crack Span 6

# Blue Mesa Middle Bridge Defects

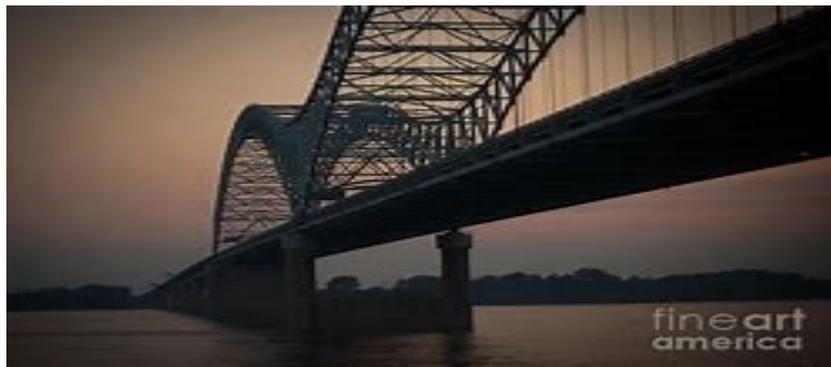
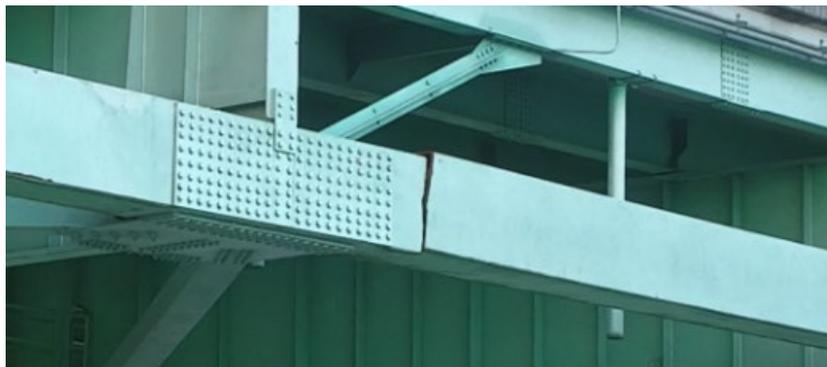
May 11, 2021 a fracture was discovered in one of the main span tension ties at the location of a butt weld in the I-40 Hernando de Soto Bridge, Arkansas/Tennessee.

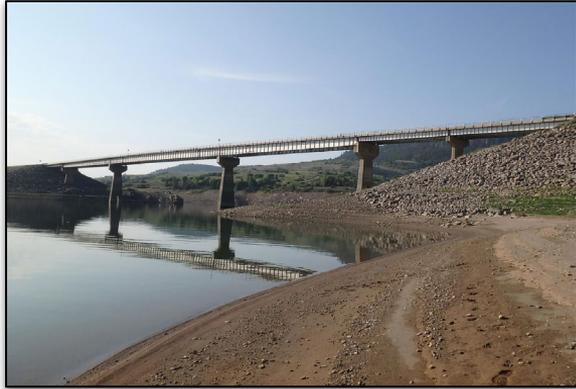
**K-07-A**

- US 50 over the Lake Fork at mile marker 132.69
- 6 Span, Continuous Composite Welded Girder bridge. 993ft, 300ft max span
- Spans 3, 4, and 5 are Non-redundant Steel Tension Members (NSTM).
- 2 total lanes, 1 lane each direction
- Built 1963, FAIR Condition

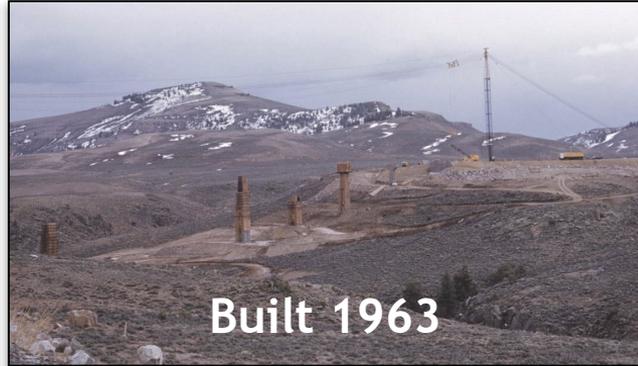
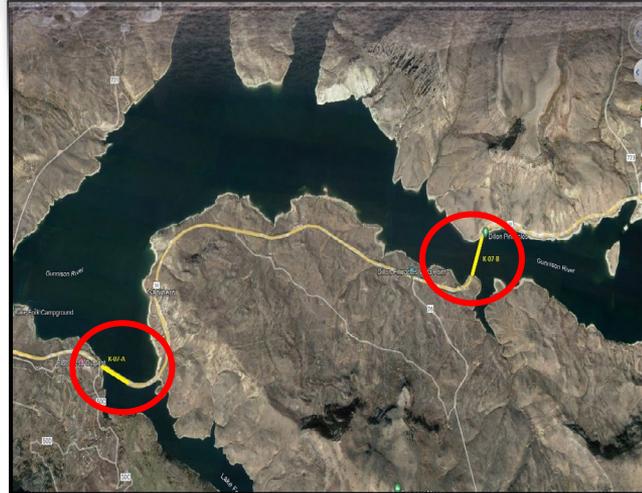
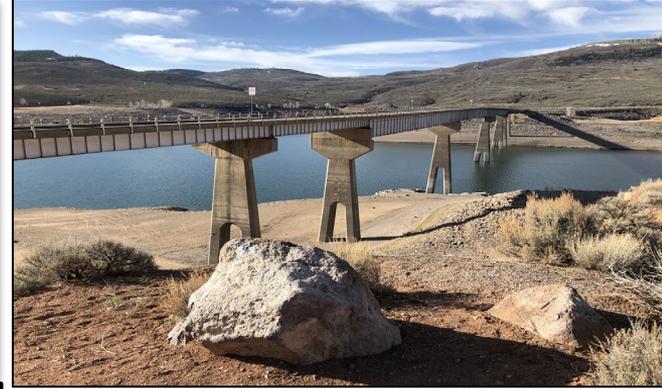
**Built 1963**

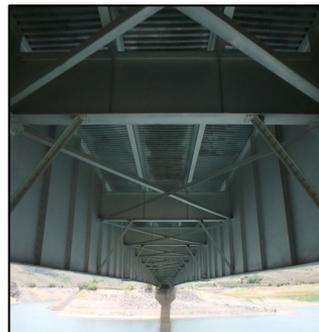
- The bridges are composed of 100 ksi T1 Steel built-Up (welded) members and is a NSTM (Non-Redundant Steel Tension Member) bridge

Two Girder Line System

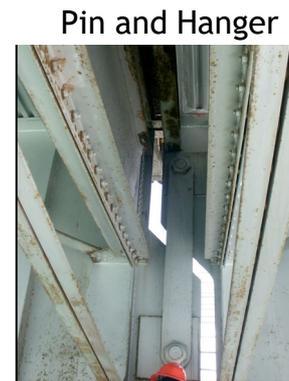
Pin and Hanger

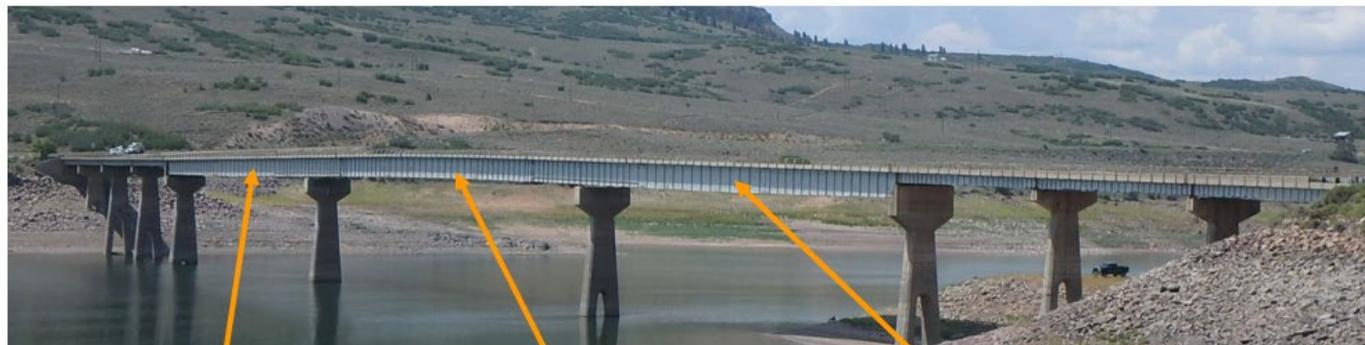
Span 5 = 270'

Span 6 = 360'

Span 7 = 270'

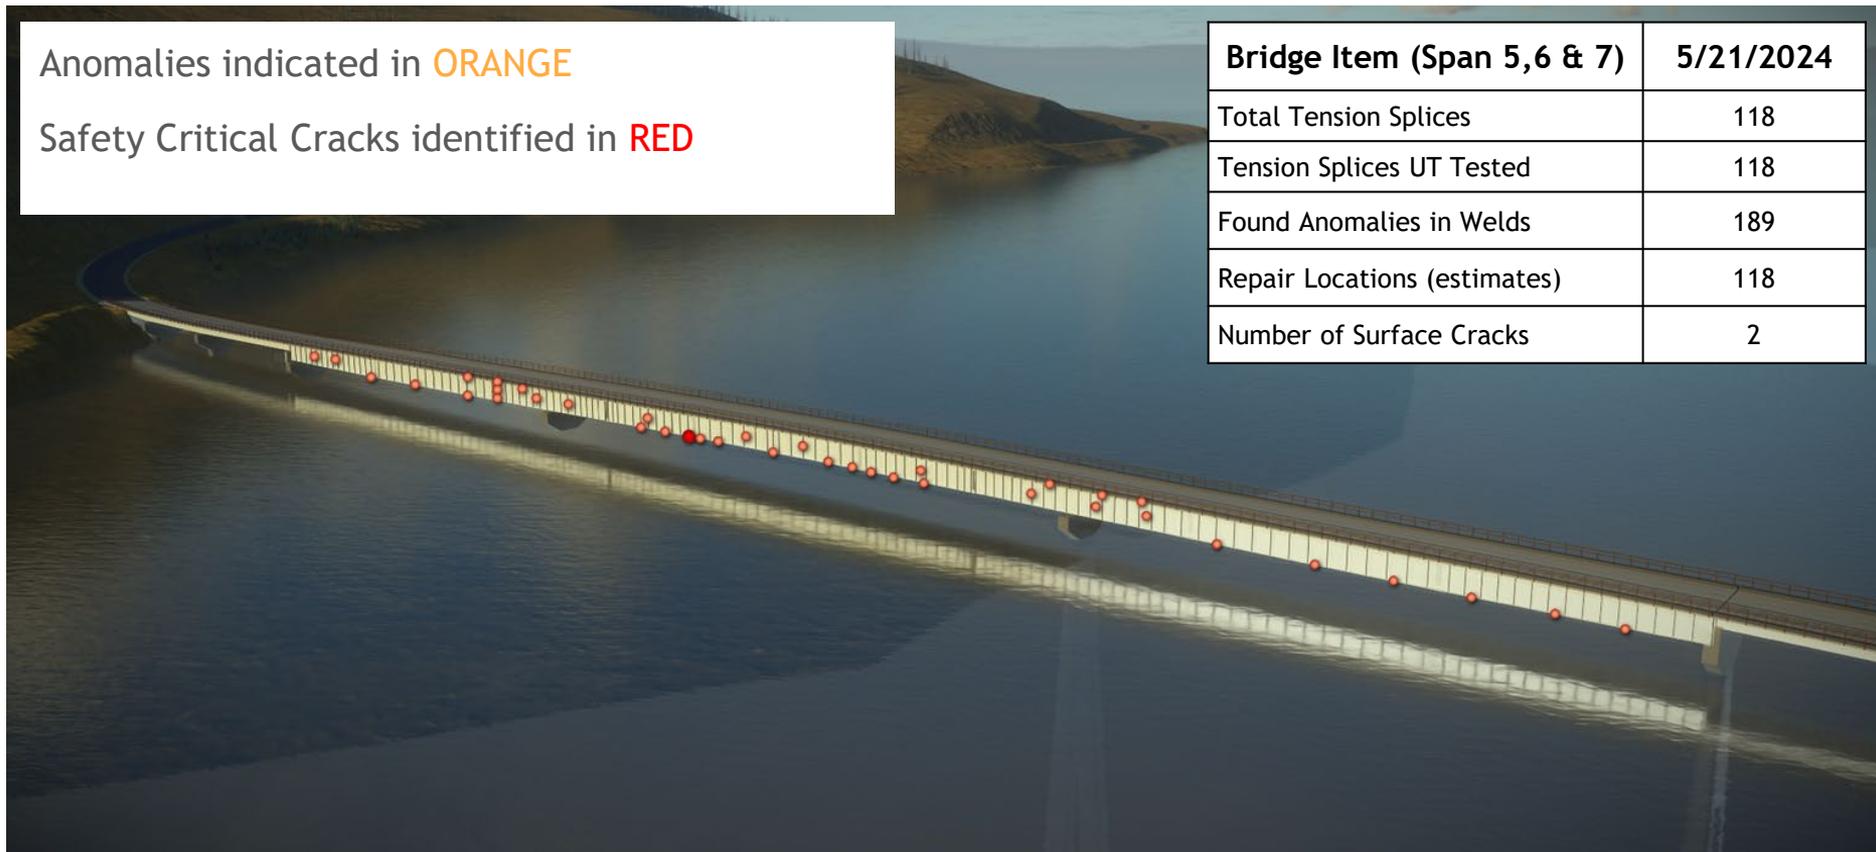
Anomalies indicated in **ORANGE**

Safety Critical Cracks identified in **RED**

Bridge Item (Span 5,6 & 7)	5/21/2024
Total Tension Splices	118
Tension Splices UT Tested	118
Found Anomalies in Welds	189
Repair Locations (estimates)	118
Number of Surface Cracks	2

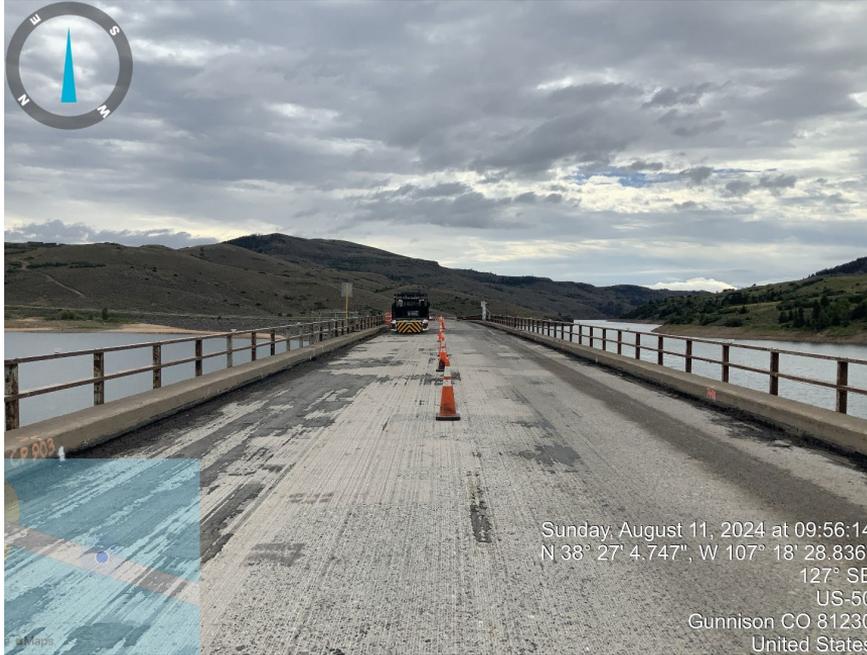
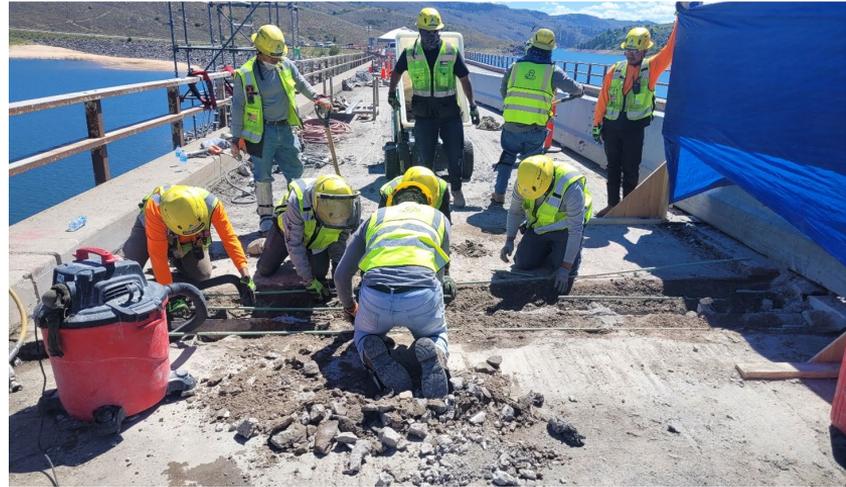
# Milling, expansion devices, poly overlay

- Reduce weight
- Waterproof deck
